DEFECTS IDENTIFICATION OF SOEKARNO-HATTA BRIDGE

Yuda Nureksa¹, Suhariyanto², Sumardi³,

ABSTRACT

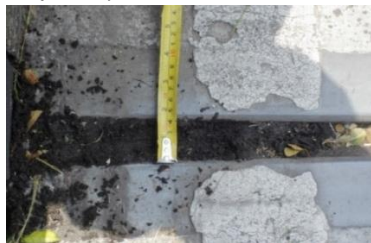
- The results of the assessment with the highest Condition Value of Level 3 are in the element 3,600 joints/expansion rays with 803 loose parts. A condition score of "2" was obtained.

- There is a gap of 45 mm between expansion joints based on U.S. Department of Transportation regulations. In 2015, the allowable gap is 25 mm.

Figure 2. Damage Loose pieces in expansion joints. Element 3,600

| LEVEL 3 | | | | |
|---|--|---|---|---|
| 3.600 | Expansion Joint | 2 | Medium Damage | Periodical Maintenance |

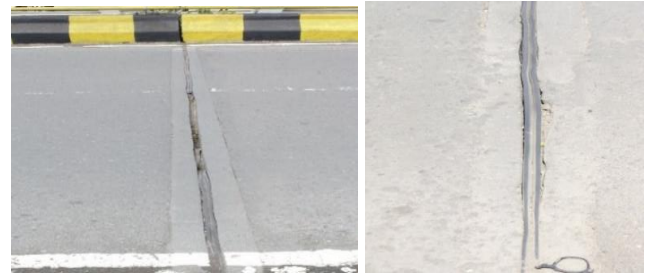
- The assessment result with the highest Condition Value of Level 3 is an element with 3,600 joints/expansion rays and 804 loose attachments. A condition score of "2" was obtained.

Figure 4.Damage 804. Loose of rubber adhesion. Element 4.603

- Expansion joint damage is the loosening of the rubber pad attachment to the expansion joint. This damage occurs because the rubber pads on the compensator are detached and lost, the damage occurs along the span of the compensator. where a condition value of "2" means that the element is in a state of moderate damage with major damage that has not yet expanded.

| LEVEL 3 | | | | |
|---|---|---|---|---|
| 3.600 | Expansion Joint | 2 | Medium Damage | Periodical Maintenance |

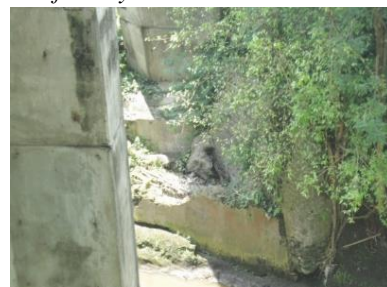
- The assessment result with the highest condition value at Level 3 is element 3.320 f pillar head beam (pile cap) with damage 205 broken or partial loss of concrete (loose). A condition score of "2" was obtained.
- Damage to element 4.323 f is damage to structural elements that directly affect the failure or collapse of the bridge. So this damage requires regular monitoring, and maintenance.

Figure 5.Rupture Damage or partial loss of the concrete

- Pile cap damage is the occurrence of spalling or cracking and/or partial loss of concrete on the pile cap. This damage occurs due to the impact of external forces, with a condition value of "2" meaning that the element is in a state of moderate damage with major damage that has not yet expanded.

| LEVEL 3 | | | | |
|---|--|---|---|---|
| 3.320 | Abutment/ Pier | 2 | Medium Damage | Periodical Maintanance |
