DEFECTS IDENTIFICATION OF SOEKARNO-HATTA BRIDGE

Yuda Nureksa¹, Suhariyanto², Sumardi³,

ABSTRACT

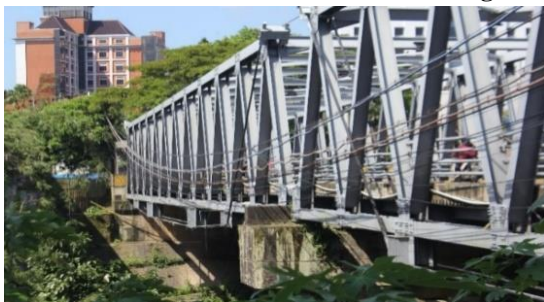
Figure 1. Side View of Steel Truss Bridge

- The overall bridge value or Level 1 rating is "1", which means the bridge is in a state of minor damage.
- The results of the analysis of the highest condition value at Level 3, which is the compensator. The condition value of "2" means that the condition is moderately damaged.

- The condition value at Level 1 is "1", which means that the overall condition of the bridge is in a state of minor damage or has minor damage and has not expanded on each element as a whole the proposed results of bridge handling is routine maintenance.
- The highest condition value at Level 3 is Element 3.600, a condition value of "2" means that the condition of the element is in a state of damage requiring handling, or moderate damage, or minor damage that has expanded, or major damage that has not expanded. Items with this condition require monitoring. The purpose of monitoring is usually to ensure that repairs or maintenance are performed in the future.
